# THE PHOTOCONDUCTIVE LAYER OF AVCS-APT VIDICON TUBES

JOHN J. PARK

JUNE 1970

GODDARD SPACE FLIGHT CENTER

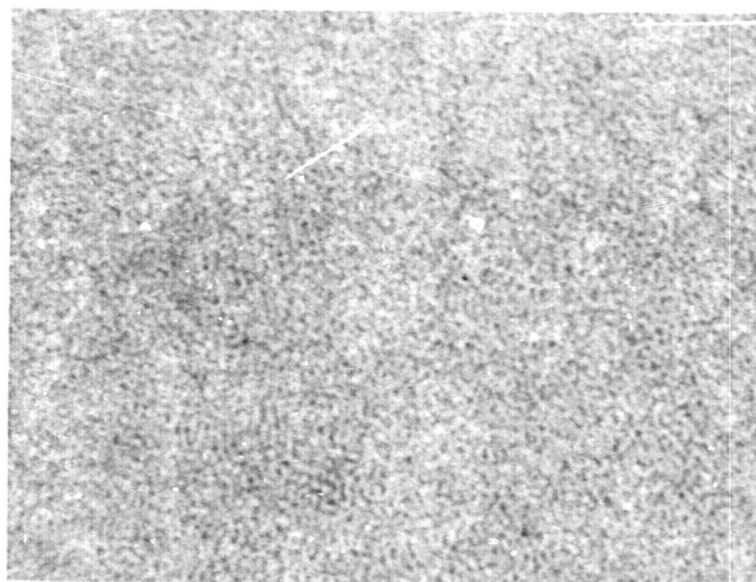
Figure 4. Photoconductive Surface as Observed at High Magnification

A. Set 2, Plate 1 x 1000

B. Set 2, Plate 2 x 1000

C. Set 1, Plate 5 x 1000

D. Set 2, Plate 1, Scanning Electron  
Microscope Picture X8500

In preparing the face plates of Set 2 for electron probe analysis, it had been noticed that the appearance of the photoconductor surface was relatively rough. For the Set 1 it had been difficult to focus visually on the surface because of its obvious smoothness and uniformity. This difference in appearance at 1000X is shown in Figure 4, with the larger "grains" being for the Set 2 face plates, as compared with a Set 1 face plate.

In the scanning electron microscope, the higher magnification and the greater depth of field show the unusual appearance of the Set 2 plates. At 8500X, see Figure 4D, it is apparent that the photoconductor is "spongy" appearing or is separated into relatively large discrete areas.

An estimate of the apparent size of the "grains" in face plates 1 and 2 of Figure 4 was made. Using the micrograph of a scale at the same magnification, the diameter of the "grains" in Plate 1, Figure 4A, is about 0.004 mm and in Plate 2, Figure 4B, is about 0.008 mm. For Plate 5 of Set 1, Figure 4C, the diameter is obviously very small, being perhaps 0.0001 mm, though it is very difficult to estimate.

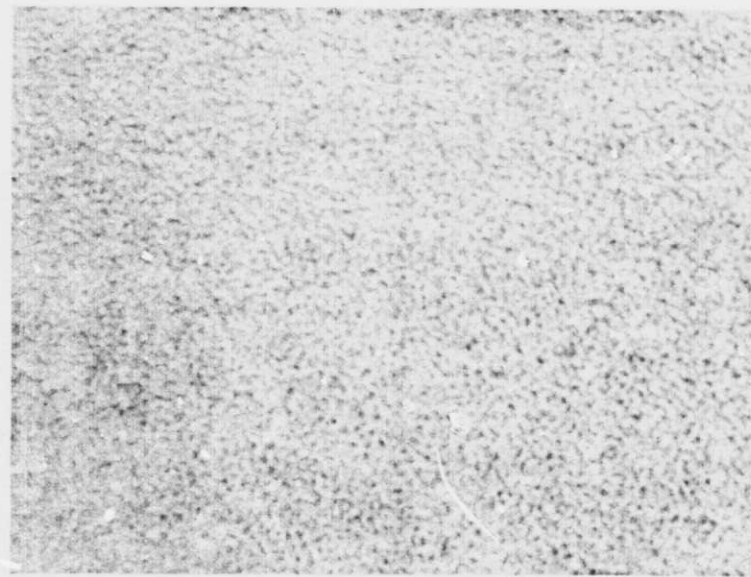
Figure 11. Appearance of Photoconductor Surface. Reflected Light, 1000 X

A. Set 7, Sample 1

B. Set 7, Sample 2

C. Set 8, Sample 1

D. Set 8, Sample 2

Under normal conditions, the observation of the photoconductor surface at 1000X was not easy, due to the difficulty of focusing on such a smooth surface. However, once it was noted that there were differences in appearance the observations became more than a routine operation. A number of surfaces had what were called "grains," the appearance being similar to an etched metallographic sample with grain boundaries.

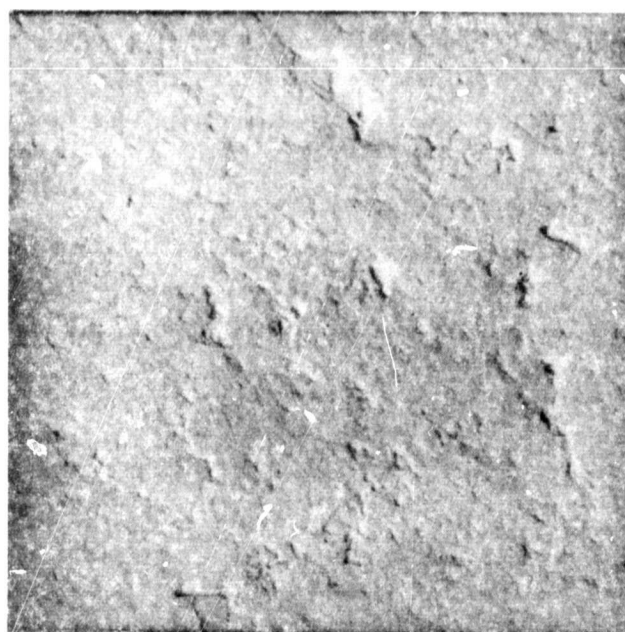
Figure 12. Phase II, Set 11, Sample 3 Sample Surfaces

A. Optical Microscope, X1000

B. Nesa Coating Surface, Electron  
Microscope Replica, X11,000

C. Photoconductive Surface, Electron  
Microscope Replica, X11,000
